R. J. Moore Home Inspections

Property Inspection Report

Pleasant Way

GENERAL INFORMATION	3
ROOF SYSTEM	5
ATTIC AND ROOF FRAMING	8
PLUMBING	10
ELECTRICAL	16
HEATING & AIR CONDITIONING	21
GARAGE	25
INTERIOR	27
KITCHEN	33
BATHROOMS	34
LAUNDRY	40
EXTERIOR	41
GROUNDS	44
FOUNDATION	49

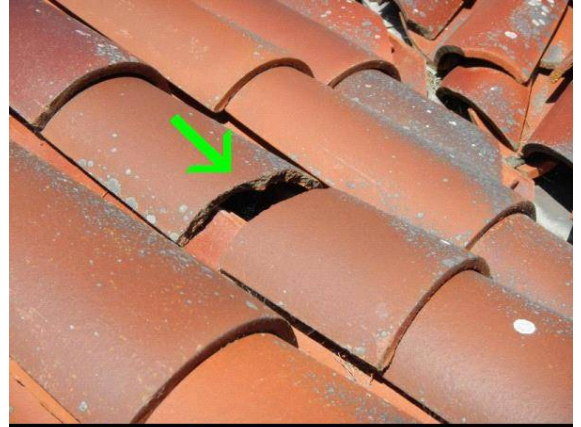
There were a few damaged roof tiles. Repair is needed to prevent potential damage as a result of water intrusion.

Damaged roof tile

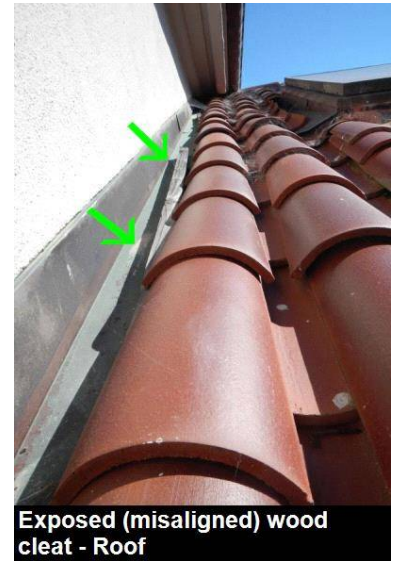
There were sections of exposed (misaligned) wood cleats visible at the area of the roof above the kitchen. Repair is needed to prevent damage to the wood as a result of exposure to moisture and sunlight.

Exposed (misaligned) wood cleat - Roof

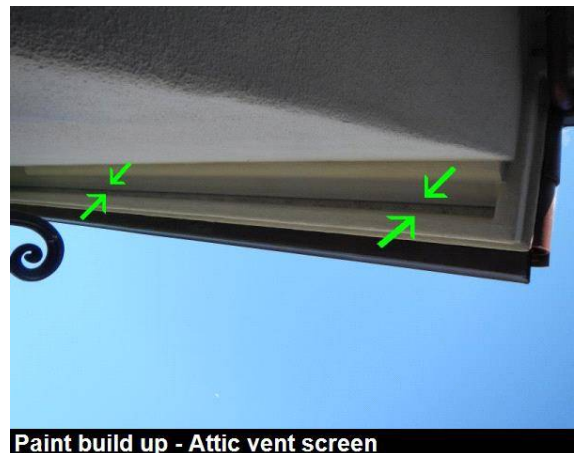
Various locations: There was paint build up on the soffit vent screens, a condition that restricts attic air flow which can lead to damage as a result of moisture build up. The screens should be cleared of paint. There was no visual indication of damage as a result of moisture build up at the time of the inspection.

Paint build up - Attic vent screen

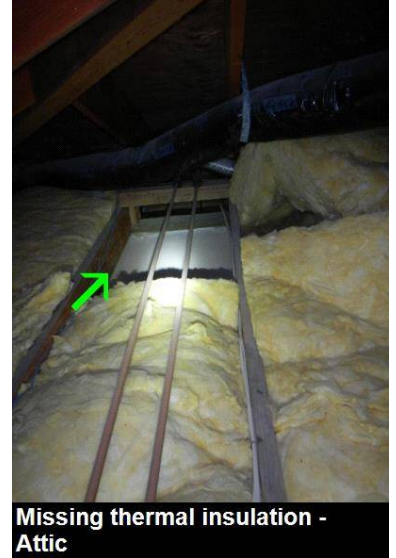
There were a few relatively small areas of missing insulation. Improvement is needed to maximize energy efficiency.

Missing thermal insulation - Attic

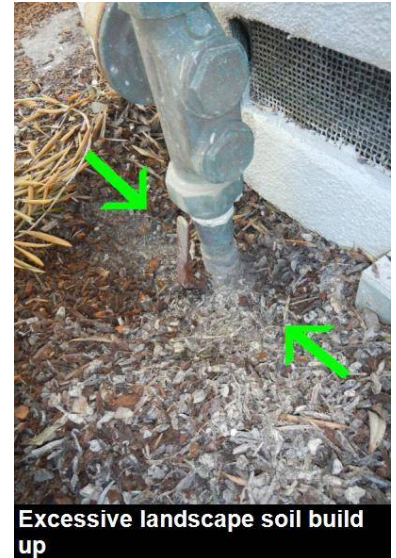
The main water supply shut-off valve was in contact with landscape soil, a condition that tends to damage the valve over time. Excessive landscape soil build up should be cleared away to correct.

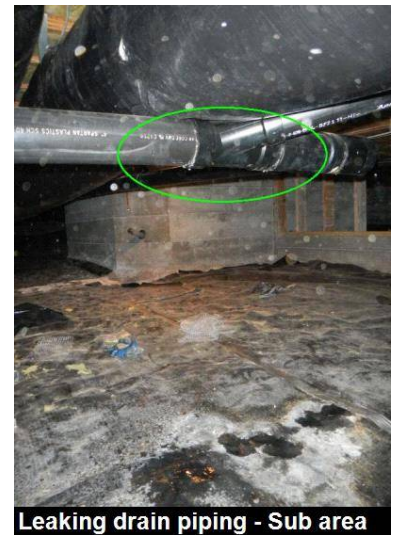
Water was leaking from the drain piping visible from the sub-area below the living room. Repair is needed.

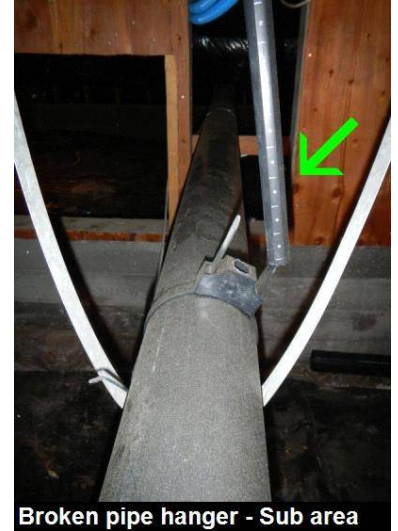
There were a few broken supports at the drain piping visible in the sub-area. Repair is needed.

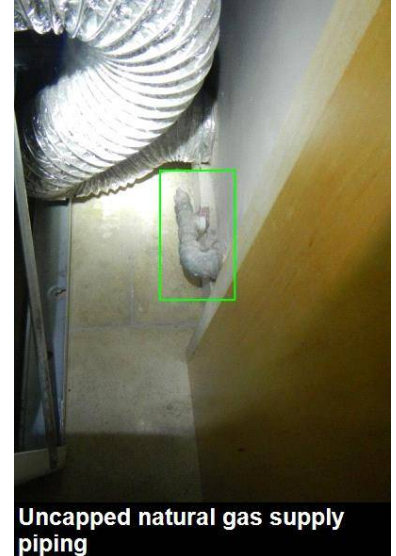
There was uncapped gas piping in the laundry room, a condition that is a fire hazard. Repair must be completed for safety. Although the end of the piping was fitted with a manual gas shut off valve, the piping should be properly connected to a clothes dryer or be terminated with an end-cap to prevent a potential gas leak.

Uncapped natural gas supply piping

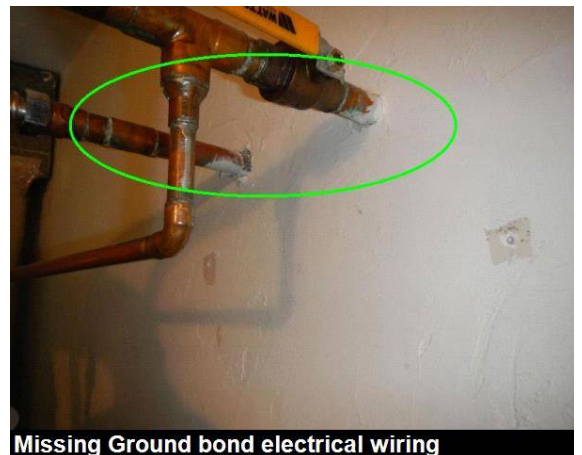
The water supply piping was not bonded to the Grounding electrical wiring visible above the water heater, a condition that is a hazard. Improvement is needed for safety.

Missing Ground bond electrical wiring

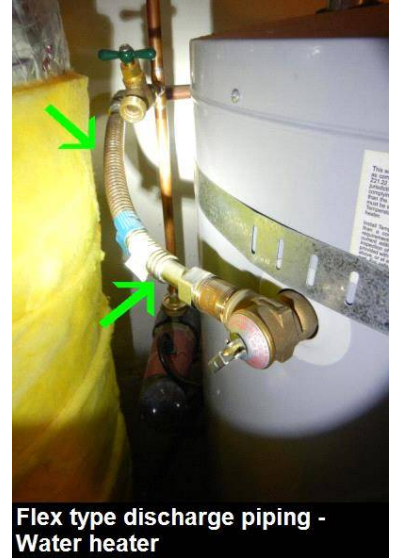
There was a section of flex type piping at the pressure relief valve discharge piping, a condition that is considered a hazard since flex type piping is prone to crimping and restriction of discharge water flow. The discharge piping should be continuous smooth wall type.

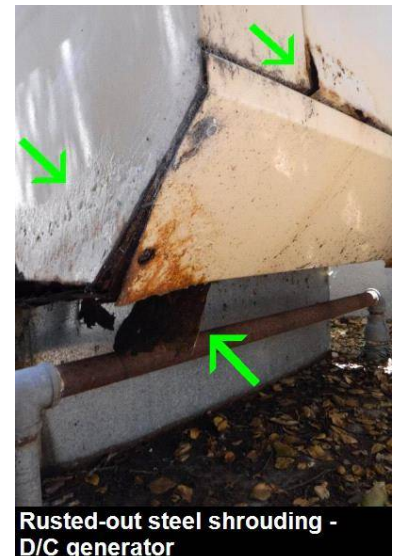
The steel shrouding for the generator was rusted-out. There was no roof cover to protect the generator from weather. Repair will likely be needed.

Rusted-out steel shrouding - D/C generator

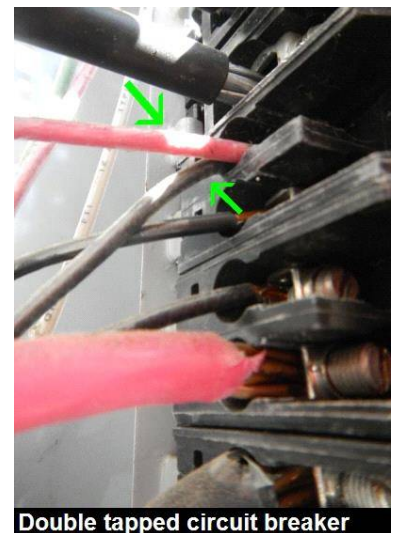
Multiple wires were connected to single lug type connection on a circuit breaker designed to carry just one wire, a condition that is a hazard. Repair is needed.

Double tapped circuit breaker

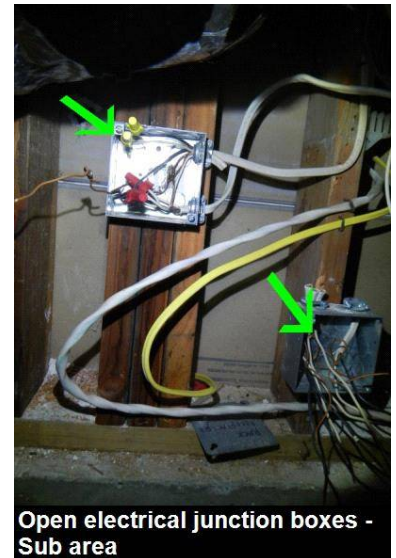
The open electrical boxes in the sub-area should have cover-plates installed for safety.

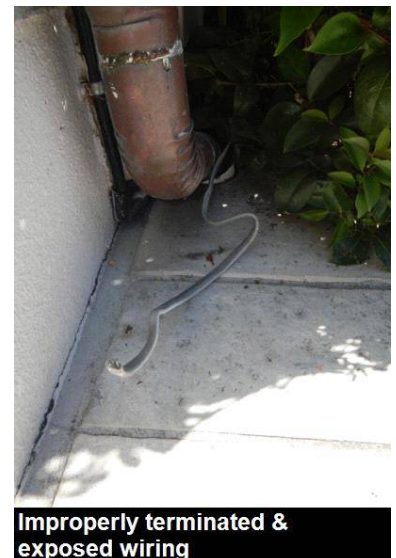
Base of the rear exterior wall: The improperly terminated electrical wiring should be repaired. Terminations should be inside electrical junction boxes and the boxes should be have cover-plates.

Exposed electrical wiring should be inside of electrical conduit.

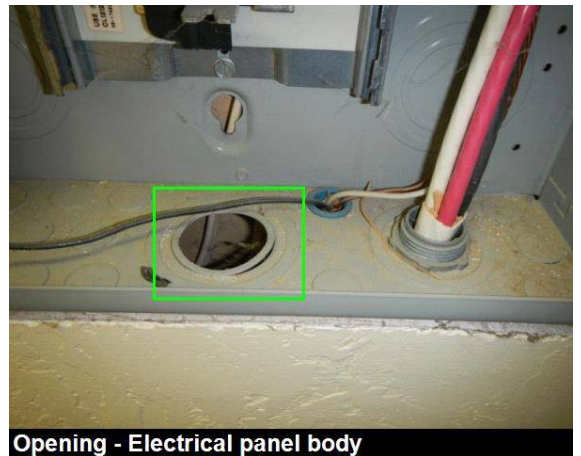
Openings at the sub-panel body should be fitted with cover plates for safety.

Opening - Electrical panel body

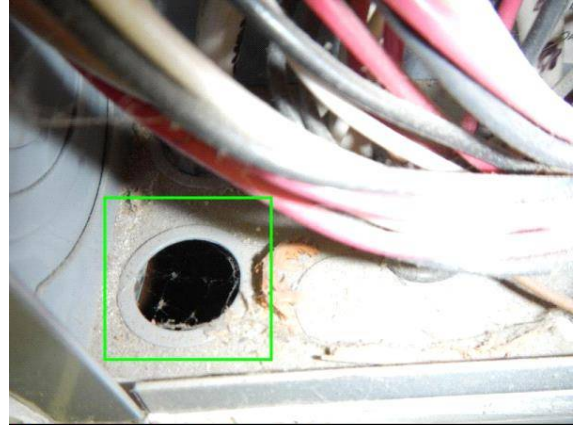
Opening - Electrical panel body

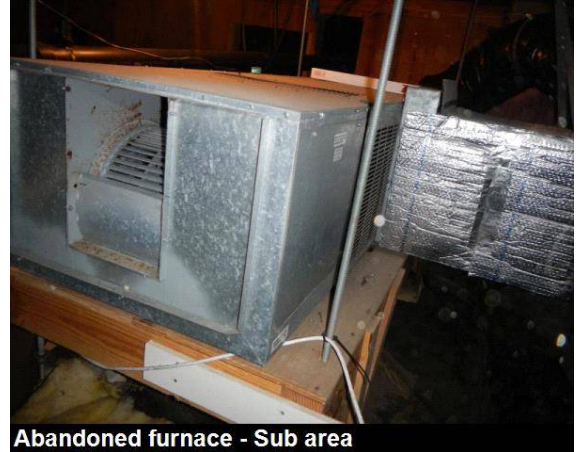
Sub area below the right front of the building: There was an abandoned furnace, remains of the original heating system.

Abandoned furnace - Sub area

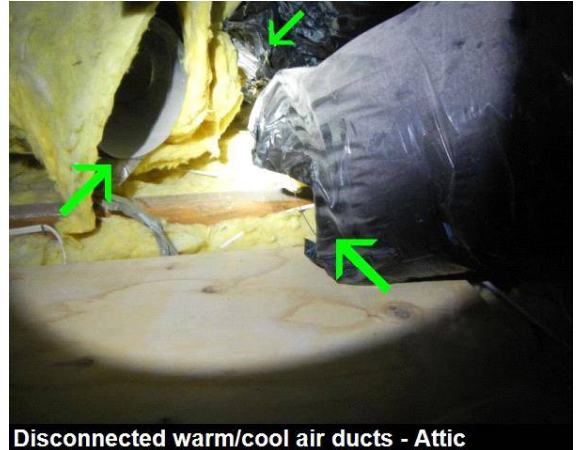
Attic above the master bedroom and various locations in the sub area:
There were disconnected sections of the warm/cool air ducts. Repair is needed.

Disconnected warm/cool air ducts - Attic

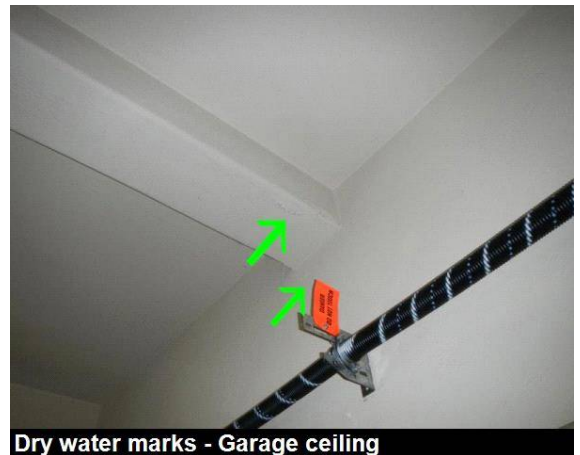
There were dry water marks on the ceiling of the garage, an indication of plumbing leak in the bathrooms directly above in the past. Monitor the surfaces of the garage ceiling for active moisture. Repair will be needed if active moisture develops.

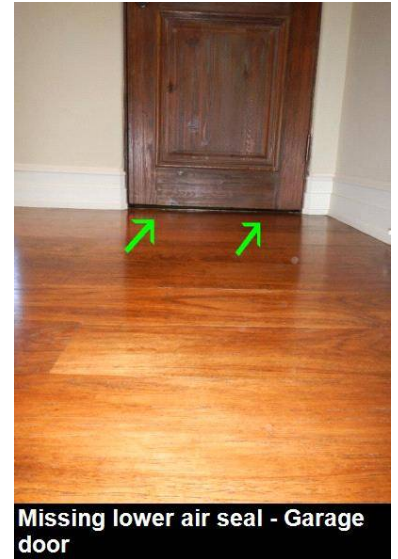
Fire door: The missing lower air seal should be replaced for safety.

Missing lower air seal - Garage door

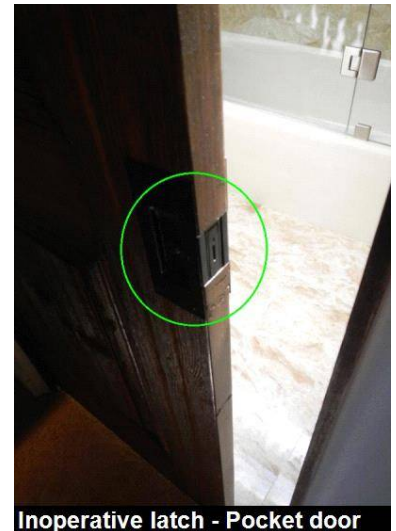
Upper level middle bathroom: The pocket door did not properly latch. Repair is needed.

Inoperative latch - Pocket door

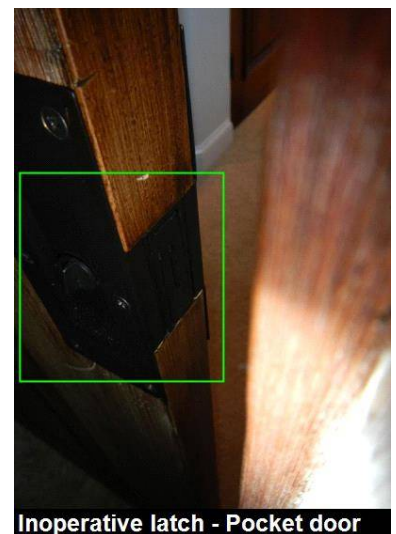
Upper level left side bathroom: The pocket door did not properly latch. Repair is needed.

Inoperative latch - Pocket door

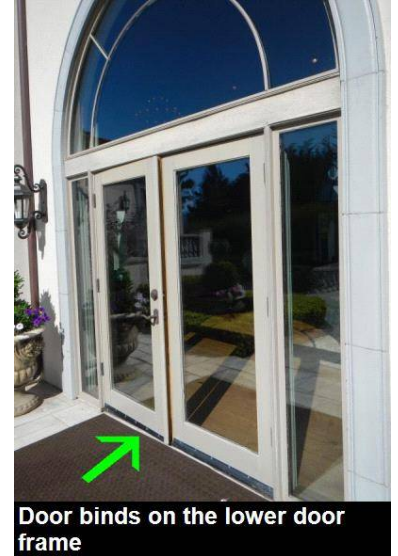
Living room rear exterior doorway: The door would bind on the lower door frame when opened and closed. Repair is needed.

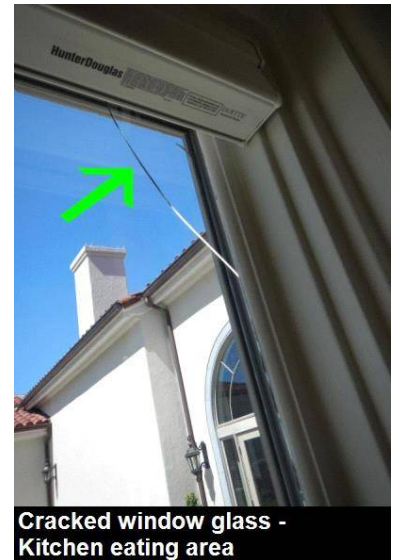
Kitchen eating area: Cracked glass at the window should be replaced.

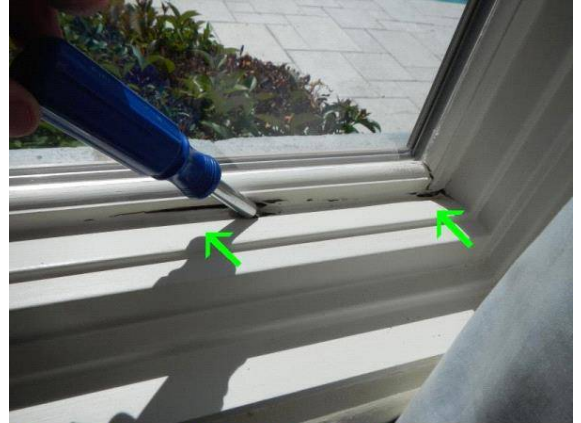
Kitchen eating area: There was a damaged wood window frame, a condition apparently due to exposure to moisture. Repair is needed.

Damaged wood window frame - Kitchen

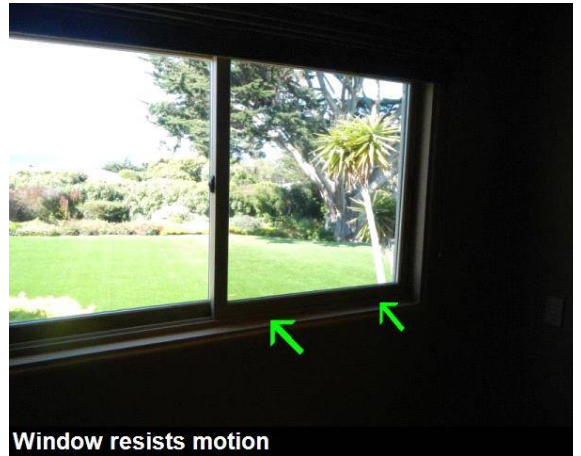
Library: There was a sliding type window that resisted motion when tested (would not open). Repair is needed.

Window resists motion

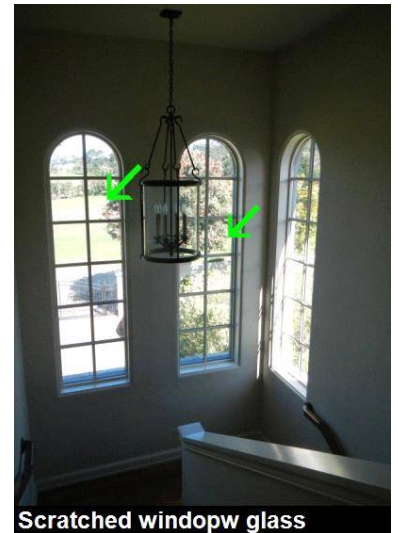
Right side upper level stairway: There was scratched window glass.

Scratched window glass

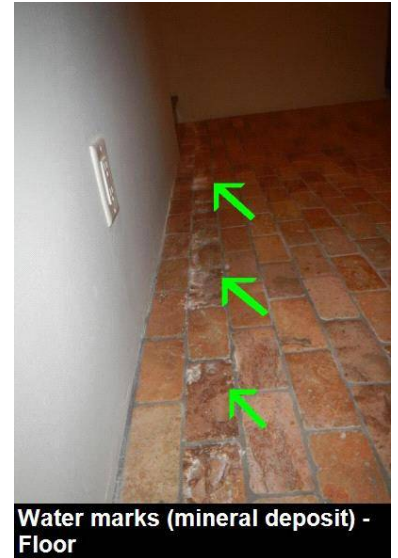
Basement (wine storage room): There were dry water marks (mineral deposit) on the surface of the floor, an indication of minor moisture seepage. Monitor the surface of the floor for more significant moisture (ponding water). Improved control of site moisture in general will be needed if active ponding water develops.

Water marks (mineral deposit) - Floor

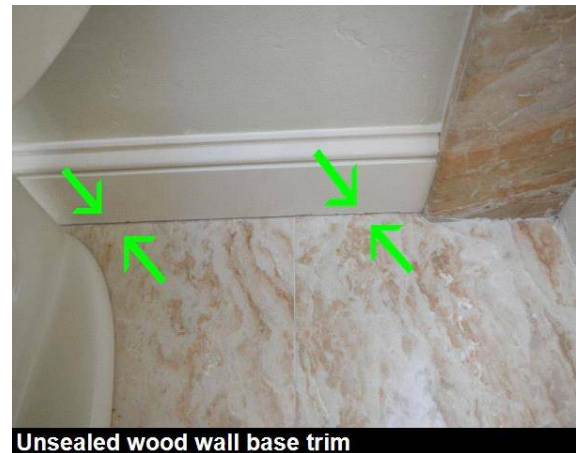
Various locations: The wood wall base trim should be sealed to the surfaces of the bathroom floors with caulking to prevent water damage. Periodic re painting of the wood wall base trim and sealing with caulking will be needed as part of the regular maintenance of the building.

Unsealed wood wall base trim

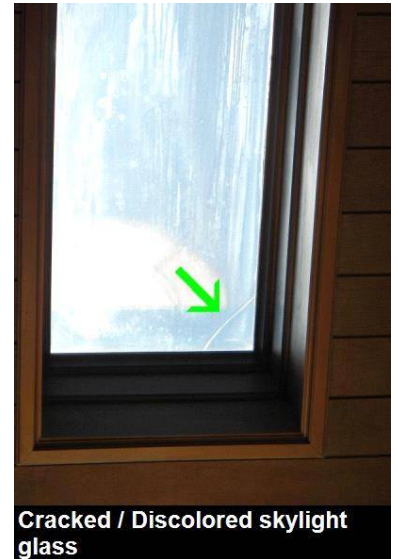
Living room: Discolored skylight glass: There was water condensation between the panes of glass, an indication that the thermal seal was defective. The insulative quality (R-value) of windows with defective thermal seals is compromised and may not be water-tight. Based on the age of the windows, there may be more skylights with defective thermal seals that could not be visually detected at the time of the general home inspection.

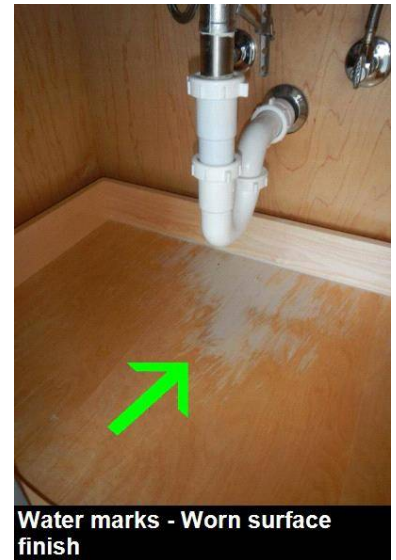
There were water marks on the cabinet below the sink, but no structural damage. The associated plumbing did not appear to be leaking water.

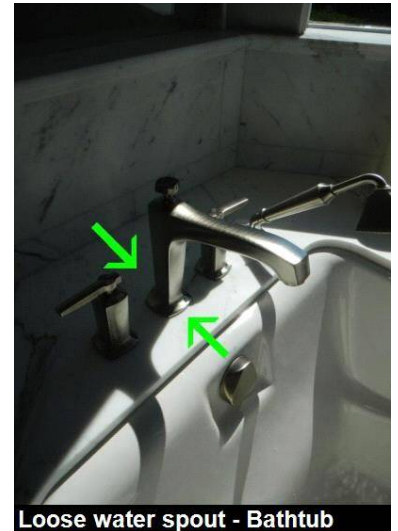
The bathtub water spout should be secured to prevent a water leak a result of movement of the plumbing.

Loose water spout - Bathtub

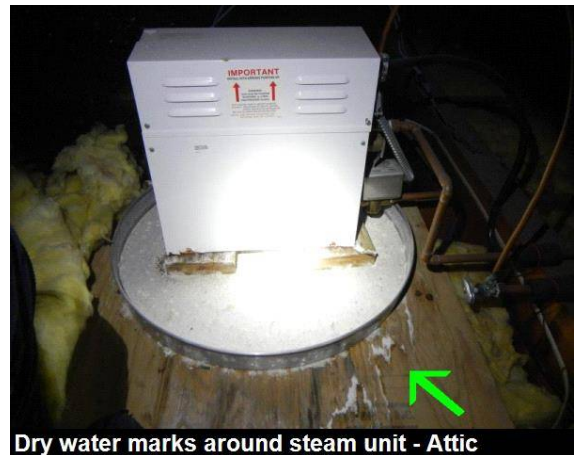
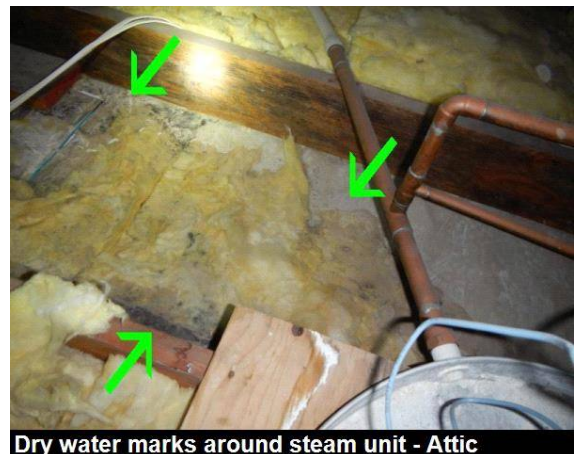
There were dry water marks on the surfaces surround the shower steam unit visible in the attic directly above, an indication that the steam unit and/or associated plumbing leaked water in the past. Monitor the attic surfaces for active moisture. Repair will be needed if active moisture develops.

Dry water marks around steam unit - Attic

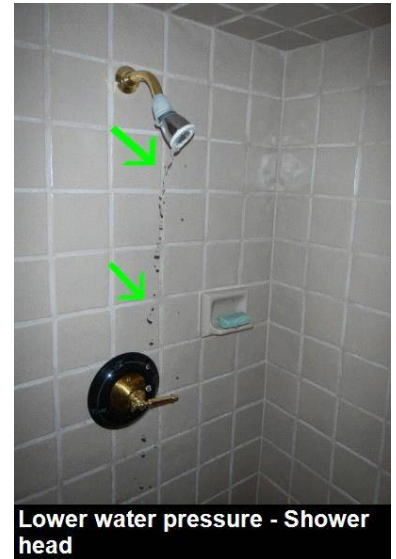
There was low water pressure at the shower head, a condition likely due to debris build up inside the shower head. Repair is needed.

Shower head was labeled 2.5 gallons per minute.

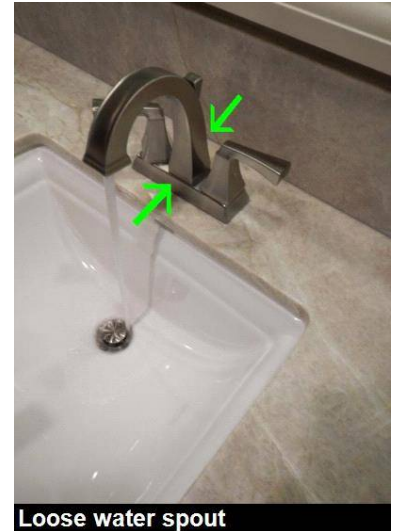
The loose water faucet water spout should be re secured to the surface of the countertop.

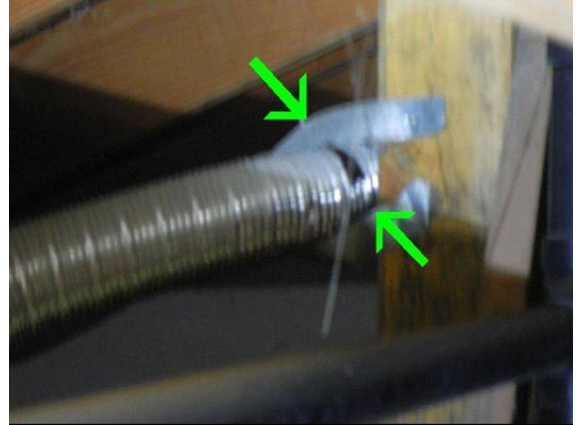
The damaged section of the exhaust fan air duct should be repaired visible from the attic.

Damaged air duct - Ceiling exhaust fan

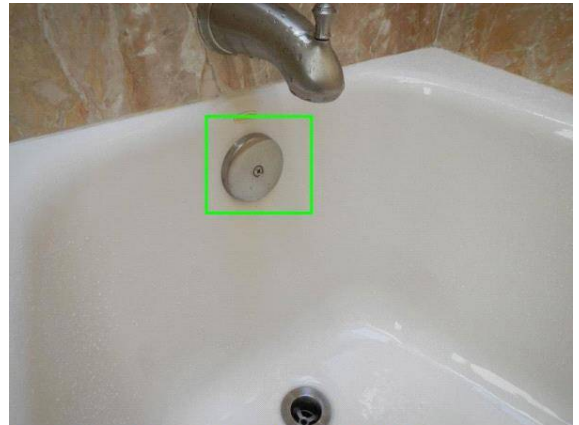
The loose bathtub overflow finish plate should be re secured.

Loose overflow finish plate - bathtub

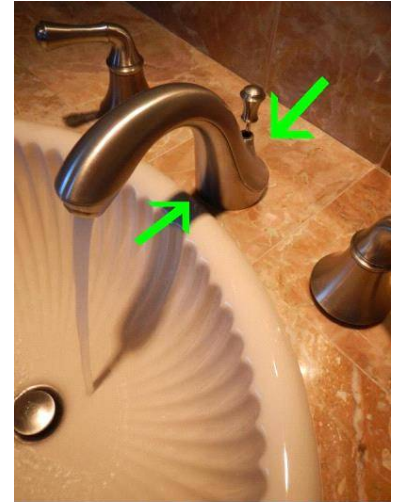
Loose water spout - Sink faucet

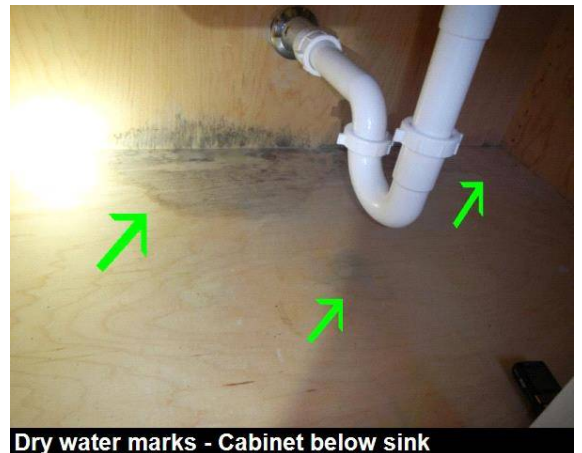
There were dry water marks on the cabinet below the sink, but no structural damage. The associated plumbing did not appear to be leaking water.

Dry water marks - Cabinet below sink

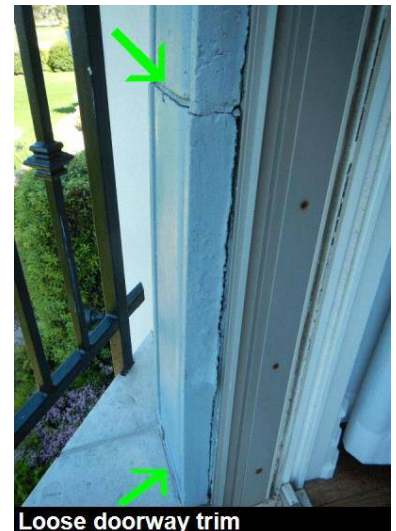
Upper level right side balcony: There was a section of loose pre-cast type doorway trim. Repair is needed.

Loose doorway trim

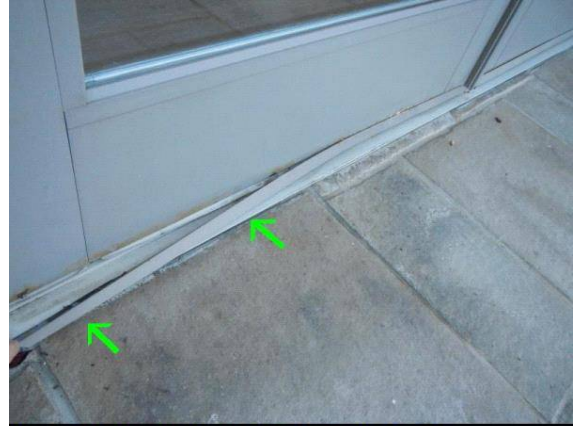
Front patio: There was a loose section of weather seal. Repair is needed.

Loose (partially detached) weather seal

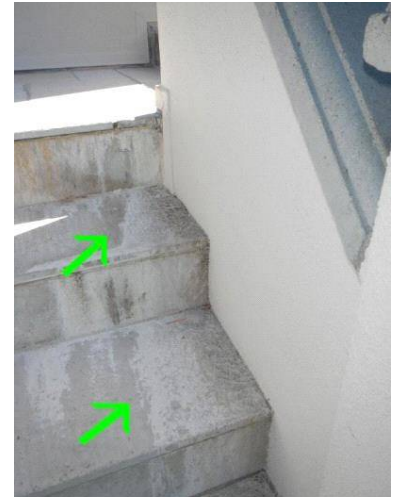
There were areas of acrylic tile sealer on the surface of the stairway tile, a condition commonly due to leaching of the sealer over time.

Leached tile sealer - Right side stairway

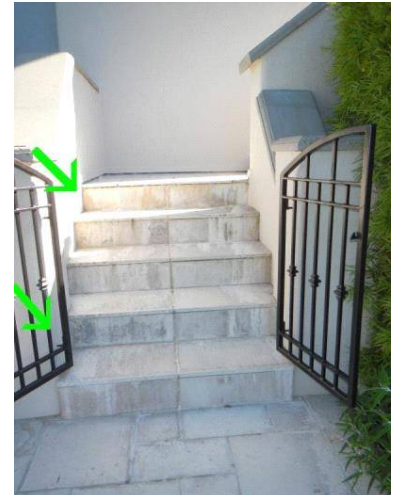
Hand railings should be installed at all exterior stairways that include 4 or more risers (steps).

Missing hand railing - Hazard

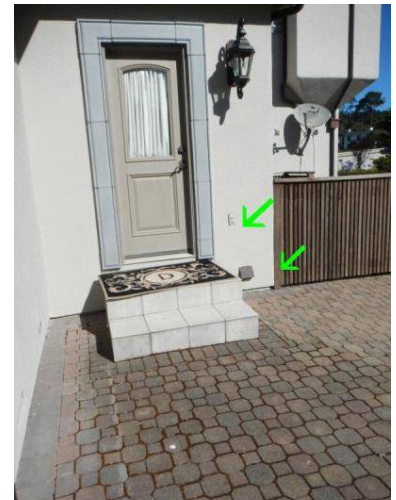
Although not required as per building standards when there are less than three steps, railings are recommended at all exterior stairways for safety.

Hand railing is recommended for safety

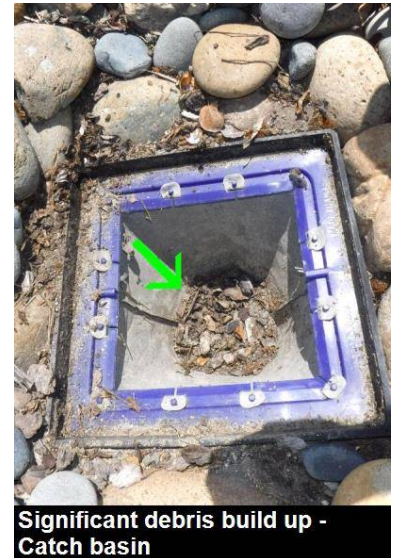
There was significant debris inside of the some of the surface drain opening catch basins.

Significant debris build up -
Catch basin

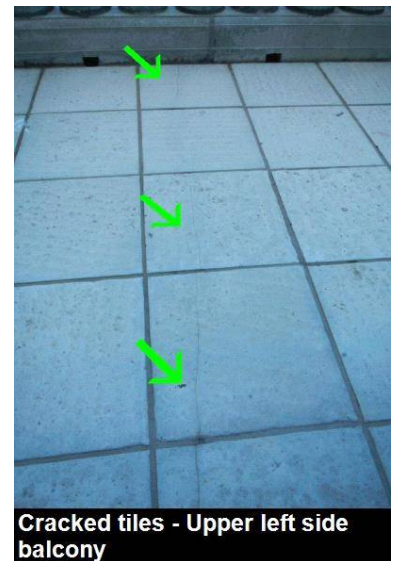
UPPER LEVEL LEFT FRONT BALCONY:
CONDITION:
There a few cracked tiles.

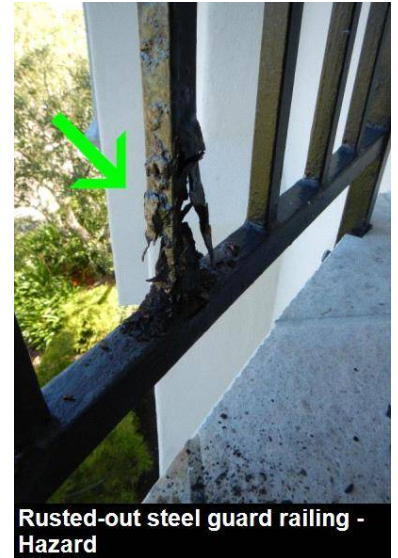
The steel guard railing was rusted-out, a condition that is a hazard. Repair is needed for safety.

Rusted-out steel guard railing - Hazard

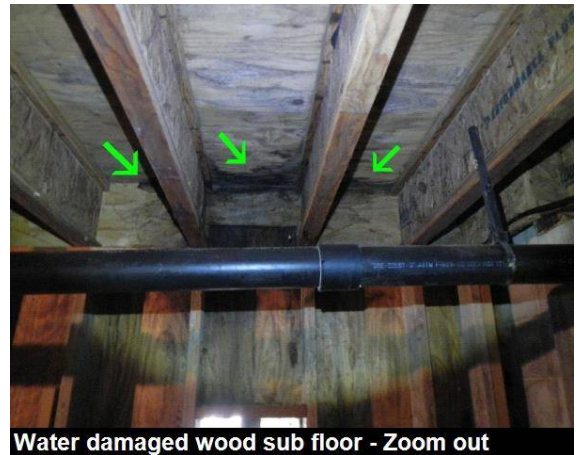
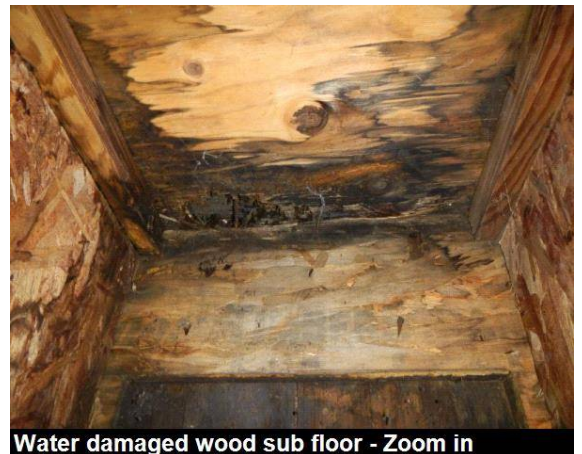
There was an area of water damage on the structural wood sub floor below the front patio, a condition apparently due to ineffective waterproofing. Repair is needed. Further invasive inspection is needed to determine the extent of the repair.

Water damaged wood sub floor - Zoom out

Water damaged wood sub floor - Zoom in

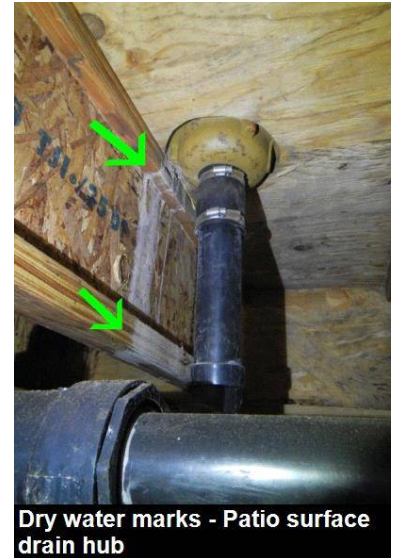
There were dry water marks on the underside of one of the surface drain opening drain piping drain hubs and adjacent floor joist, and dry water marks on the surface of the vapor barrier visible in the sub area below the front patio, indications that the drain hub was leaking and/or membrane type waterproofing for the patio was not effective. Further water testing of the surface drain openings and patio waterproofing is needed to determine whether there is water leakage.

Dry water marks - Patio surface drain hub

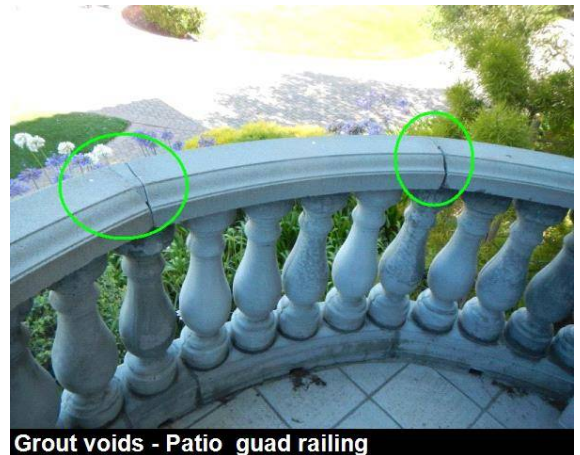
There were grout voids between adjoining sections of the pre-cast concrete guard railings. Repair is needed.

Grout voids - Patio guard railing

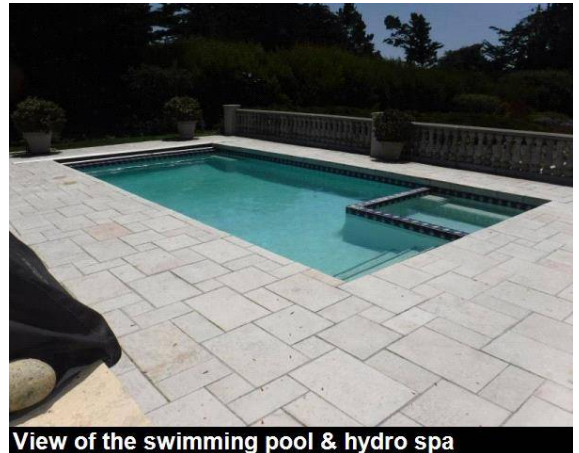
The pool cover was not marked (labeled) as an ASTM approved type.

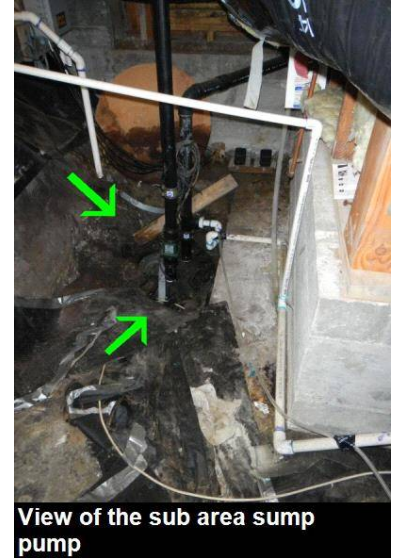
The sump for the sump pump will need to be cleared of sediment and debris as part of the regular maintenance of the building to ensure effective control of site moisture.
