TECHNICAL ARTICLE

Inspecting Floor Furnaces

Originally Written by Michael Casey and Douglas Hansen, March 1998

Updated by Skip Walker, August 2008

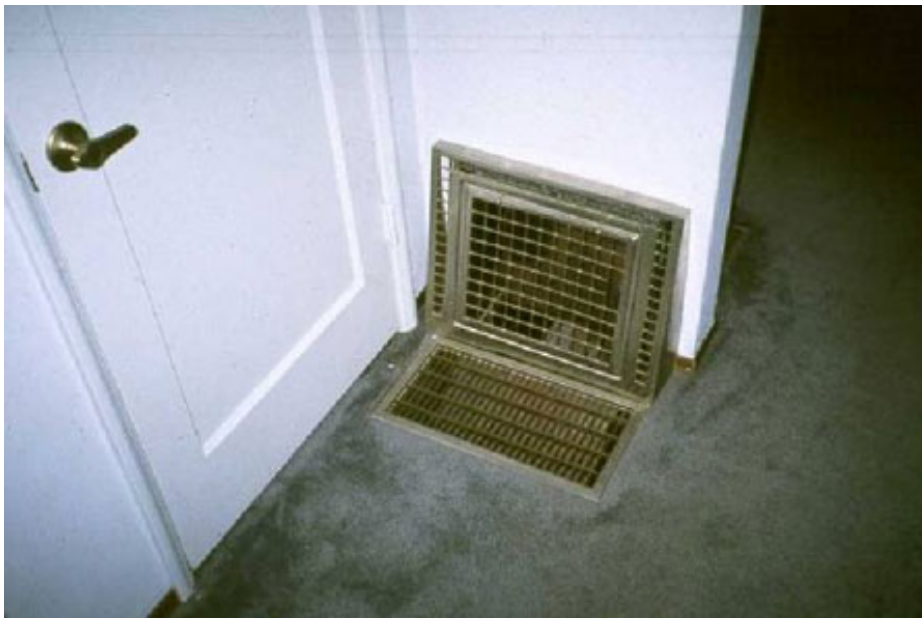
Photo 1 - Floor furnace next to door and within 6 inches of a corner

Doors should not swing over or within twelve (12) inches of floor furnaces (see Photo 1), and carpeting should not cover the grills. Doorstops or closers cannot be used in lieu of proper clearances to prevent doors from swinging within twelve (12) inches of the furnace. Other furnishings, drapes, etc should maintain a minimum of twelve inches from the register. The floor registers should not be installed on stairs, aisles, landings, and door openings/exit paths from rooms. In areas such as a hallway, the register should be installed with at least eighteen (18) inches on one side to allow occupants to walk by the unit without stepping on the register.

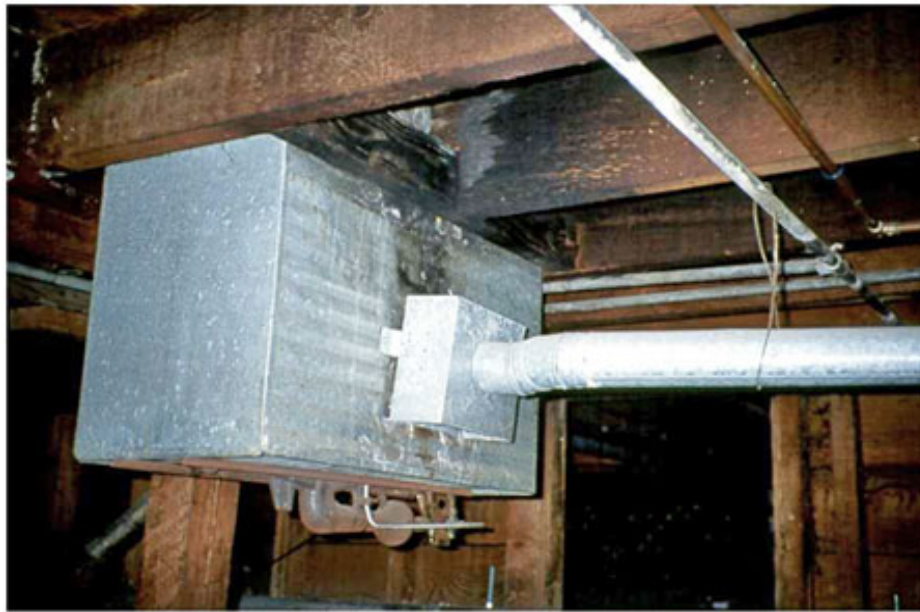
Photo 2 - Loose Draft Hood and Charred Framing

the bottom. A loose draft hood or vent connector can allow hot flue gases to escape next to the furnace, charring adjacent framing and causing fires (See Photo 2). Again, wood damaged through pyrolysis (long-term low level heat exposure) may ignite at much lower temperatures than undamaged wood. The wood color/condition adjacent to the system and all vent components should be carefully examined for indications of heat transfer. In extreme cases, the wood may be obviously charred. In some cases, the heat transfer may be less obvious and the wood may only appear caramel in color. Any indications of heat transfer should be reported. Heat damaged wood may ignite at as little as 225 °F depending on the wood type, condition, oxygen availability, etc. The flue gases may also contain high concentrations of carbon monoxide due to poor drafting and incomplete combustion, and these gases can migrate into the living space.

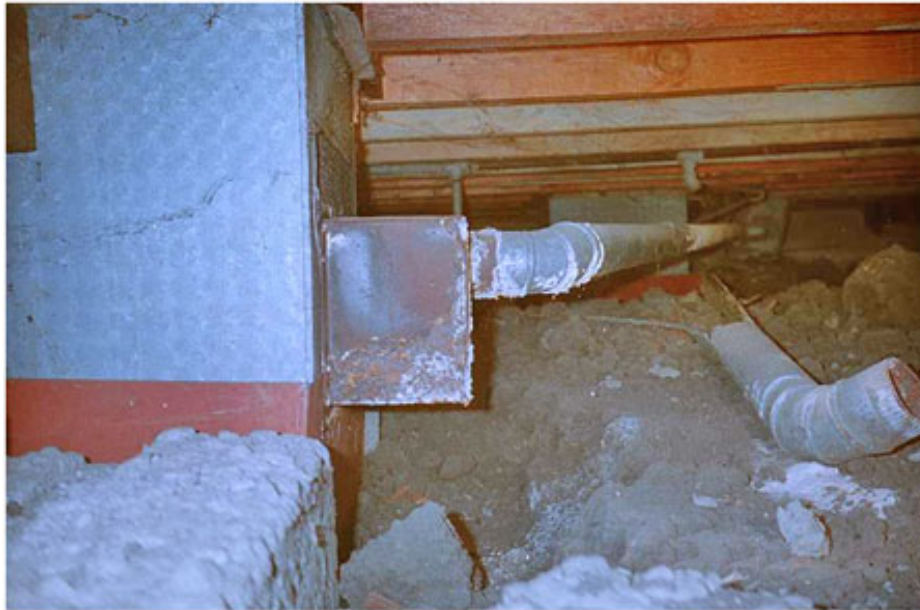
Photo 3 - Rusted Draft Hood and Discarded Old Vent

The vent connector and possibly the entire flue pipe should be a double-wall (class B) pipe. In practice, older furnaces have single wall vent connectors that are rusted, particularly at the bottom. This rust may not be evident unless the inspector makes a close examination of the vent. Looking at the vent connector from the side and a few feet away may not be sufficient to spot damage or splits on the bottom of the vent connector. The cause of this damage is moisture in the flue gases condensing in the pipe due to inadequate draft or flue temperature. Since the surrounding space is cold and unconditioned, the cooling effect on the flue causes condensation. The requirement for a Type-B vent connector has been in place since the earliest editions of the Uniform Mechanical Code. Many furnaces installed before this code are still in service with single-wall vents (photo 3). Occasionally the vent will be single-wall copper, designed to resist the corrosive effects of condensation.

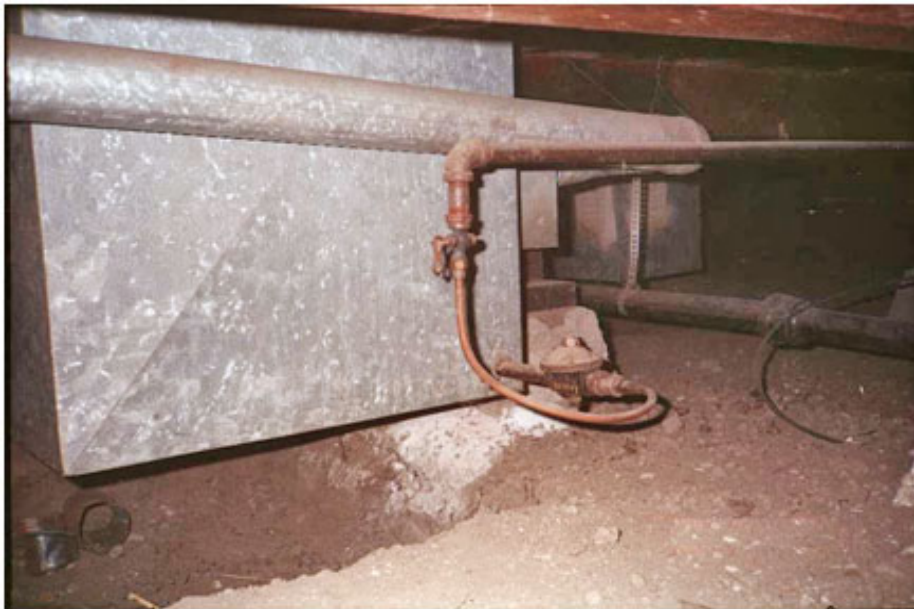
Photo 4 - Non-Safety Pilot system – Also note Condensation on Soils below Draft Hood

Keys sticking above the floor controlled older gas systems. These keys fit onto rods that controlled the pilot valve and the burner valve. Often such older furnaces had no thermocouple. If the pilot blew out, it was possible to fill the furnace with gas. Many of these old systems are still in use (Photo 4). There may be a pressure regulator with a breather tube run into the burner area. Do not mistake the breather tube for a thermocouple. In many older homes with these furnaces the long metal rod may have a slot at the end for holding the match used to light the pilot.
