## FPE Panels – Hazard or Hype?

*by Douglas Hansen*

*This article focuses on the controversy over inspecting and reporting Federal Pacific panels. It has been published in the magazine for the California Real Estate Inspection Association and in other technical journals.*

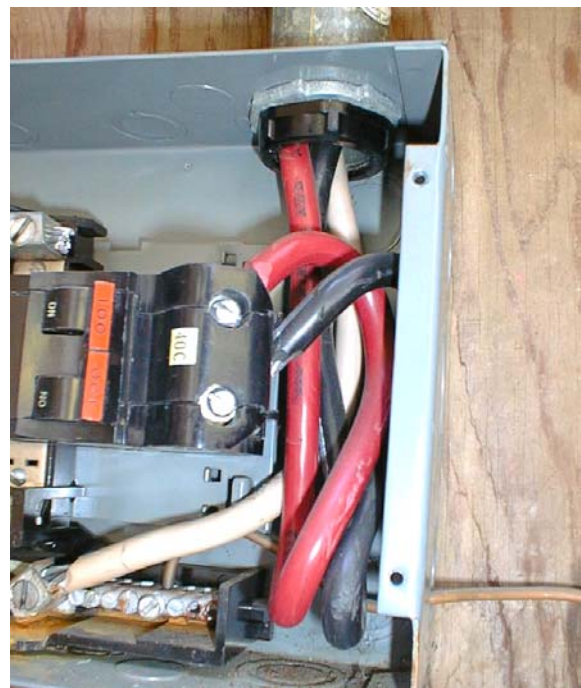
*Figure 1 – Insufficient wire bending space*

Several of the problems found with FPE panels are found in other brands of equipment of the same age. There is less gutter space in the panel than we find in modern equipment. The result is crowding of the wires in the panels. It is sometimes impossible to see all of the terminals in an FPE panel. The space for bending wires is also less than required in modern panels. The rules that proscribe minimum wire bending space are found in the National Electrical Code (NEC) in section 312.6 in the 2002 edition. Over the years, the required minimum space has increased, with the most significant changes in the 1981 NEC, near the very end of the days when FPE panels were made. FPE manufactured some panels with less clearance than the minimum code rules by installing the lugs at an angle, so the conductor was already parallel to the wall opposite the breaker terminal (figure 1). However, the bends shown in figure 1 defeat the purpose of the angled lugs, and the wire is bent too sharply.

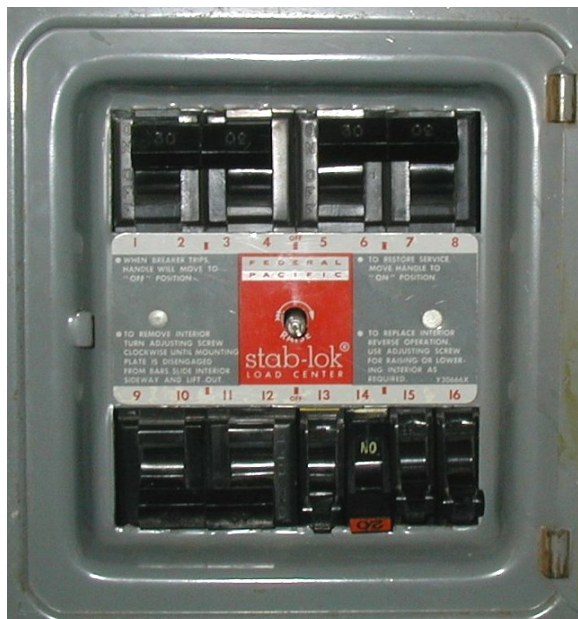
Figure 2 – Breakers that are on when down

Since the 1984 edition of the NEC, breakers that operate with their handles in a vertical position must be on when in the up position, and off in the down position. Prior to that time, several manufacturers made equipment such as that seen in figure 2, with a row of breakers that was on when down and off when up. The word “on” when upside down is “no.” Inspectors encountering such equipment might want to warn their clients that these FPE breakers are on when facing the outer edge of the panel, and off when facing the center of the panel. It can be very difficult to remove these covers without accidentally tripping a breaker.

Inspectors might find that their first problem with FPE is the difficulty in removing the deadfront cover without tripping the breakers. Several models of FPE panels have breakers that are on when the handle is positioned toward the outside of the panels. The handles stick out slightly over the deadfront, past the twist-out opening for the breaker. To remove the cover, it is necessary to first lift it slightly away from the panel, then slide it under the handles of one row while lifting the cover off the other row. If an inspector pulls the cover straight off, it is likely that some of the breakers will accidentally trip. The panels in figures 2, 3, and 4 have this problem.

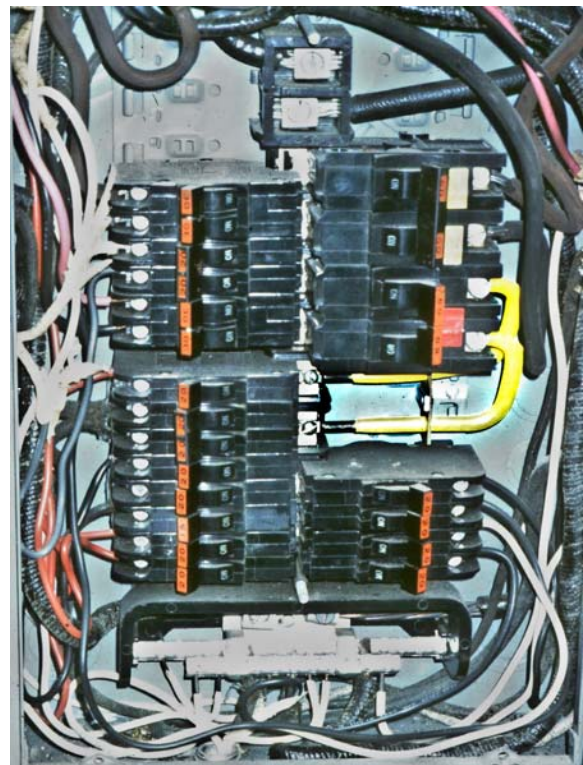
Figure 3 – Split Bus Panel

Prior to 1984, many manufacturers offered “split bus” panels for residential use, such as the panel in figure 3. These panels have no main breaker. They do meet the rule requiring no more than 6 disconnects, and one of these disconnects feeds a separate bus that typically contains the 15 and 20 amp 120 volt circuits. The advantages of a split bus panel were purely economic. If the largest breaker was the one feeding the secondary bus, and it was rated at 50 amps, it cost less than a single main 100 amp breaker. In addition to the “six disconnects” rule for service equipment, another rule also applies to panels that are categorized as “lighting and appliance” panels. These are panels where more than 10% of the breakers are rated 30 amps or less and serve circuits with neutrals. These lighting and appliance panels must be capable of having their power disconnected by not more than 2 hand movements. Until 1984, the code exempted these panels from the “two-disconnects” rule when they served as residential service equipment. Today, the code allows them to remain when they are “existing” service equipment, though it would not allow a new installation of such a panel.

The panel in Figure 3 has 5 breakers at the top. The 3 on the left control a water heater, clothes dryer, and electric space heater. The top right breaker controls the range/oven circuit, and the one just below it controls the lower bus section, with all the lighting and appliance circuits. The wires from this breaker to the lower bus section are the sign that this is a split bus panel.

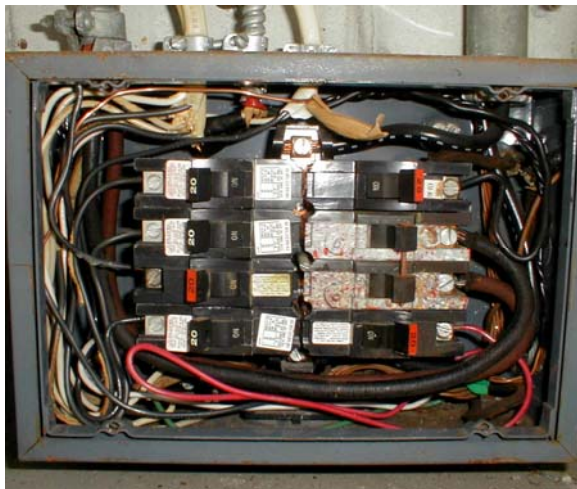
*Figure 4 – Overcrowded FPE panel with wires obscuring terminals, neutral bar, and bonding jumper. If the wires press against the deadfront, it may pop out and trip the breaker handles as soon as the panel screws are removed.*

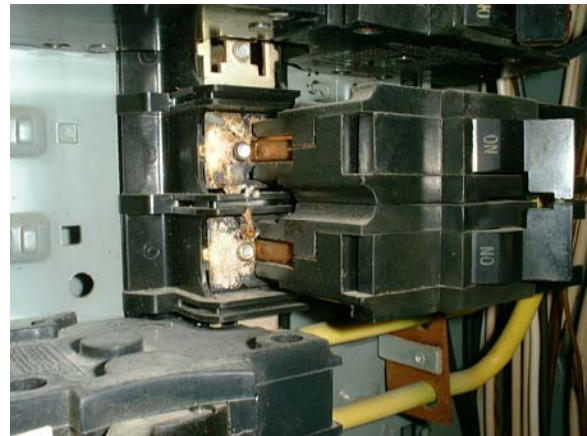
*Figure 5 – Scorched Bus Bar*

Most plug-in circuit breakers have a set of jaws that fit over a bus bar, bringing the metal of the jaw into a parallel position to the bus bar. The FPE Stablok design is the opposite; the breakers have a set of prongs that are inserted into a slot in the bus bars (figures 5 – 8). The result is a connection between two pieces of metal that are at right angles to each other, only touching at their edges. One of the common FPE problems is to find the breakers loose in the bus bars. Good electrical connections require contact pressure. If the FPE stab only touches one edge of the opening in the bus, the lack of contact pressure and the small contact area will combine to produce arcing and overheating. If you remove the breakers from the panel, it is not uncommon to find scorch marks on FPE bus bars, as in figure 5.

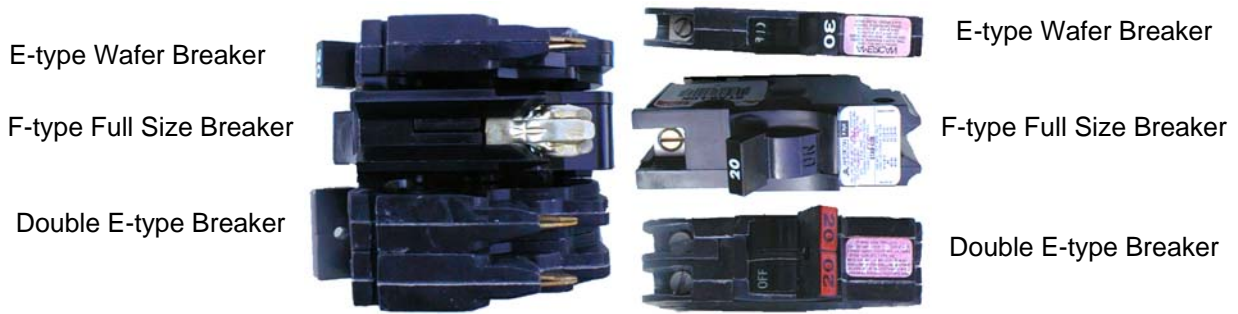
Figure 6 – “E” and “F” Breakers

FPE found a unique way of designing their wafer breakers and creating a limitation on the number of them that could fit in a CTL panel. Full size breakers have a stab that is perpendicular to the direction the breaker handle operates, and wafer breakers have a stab parallel to the direction of the breaker handle. The full size breakers stabs are referred to as “F” type, and the wafer breakers as “E” stabs (figures 6&7). FPE has two different styles of bus opening. An “E” type opening will allow either two “E” type breakers or one “F” type. An “F” type opening will only allow one breaker, of either type. The number of breakers that can fit in the panel

can therefore be limited by installing “F” type openings, instead of “E” openings.

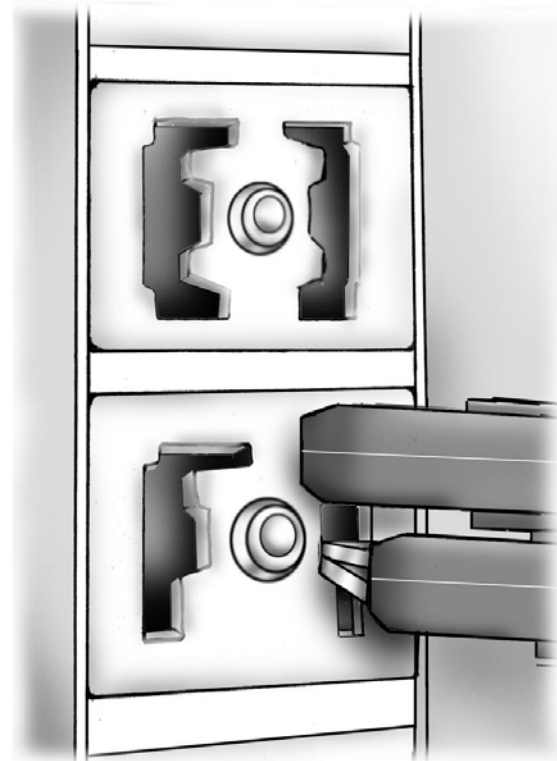
Figure 7 – “E” & “F” bus slots

The problem with this arrangement is that the “E” breaker stabs can be bent over and jammed into an “F” socket, and the result is another poor connection, as well as an overcrowded panel. Figure 7 illustrates this condition.

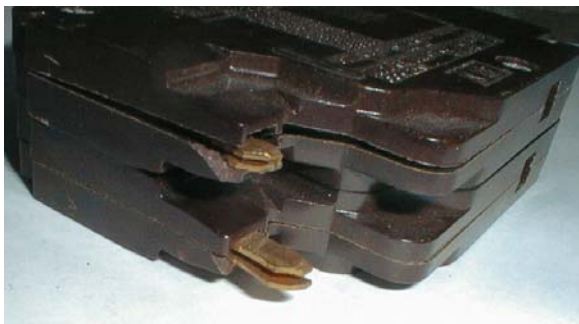
*Figure 8 – Damaged “E” type breaker*

Not only do “E” breakers make poor connection to “F” sockets, forcing them into the socket can damage them. The breaker may split when shoved into the slot, with the bus stab receding inside the breaker (figure 7). Since it is now making a very loose contact to the bus, the breaker might fall right out when the deadfront cover is removed (figure 9). Inspectors can be forewarned of this condition before taking off the cover. Simply look at the label for the panel to see where the “E” slots are located and whether any “E” breakers have been inserted into “F” slots. When finding that situation, there is no need to remove the cover to know that the breaker is in the wrong position.

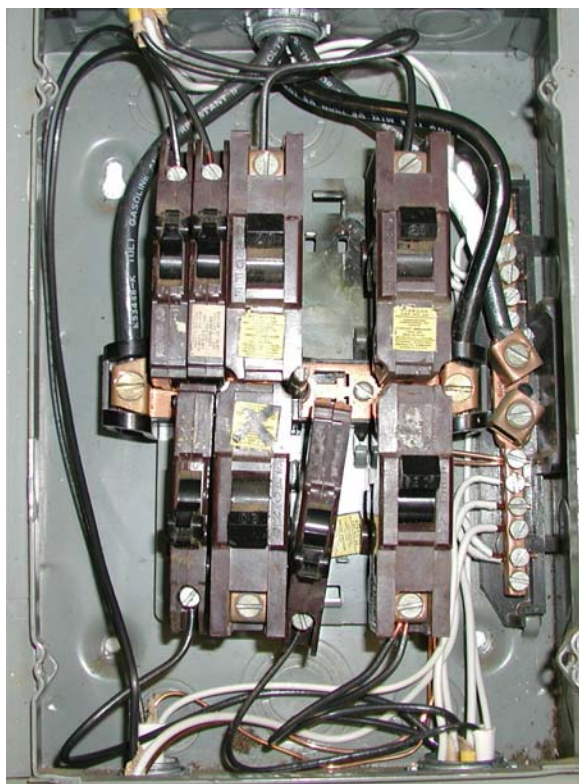
*Figure 9 – Loose breaker*

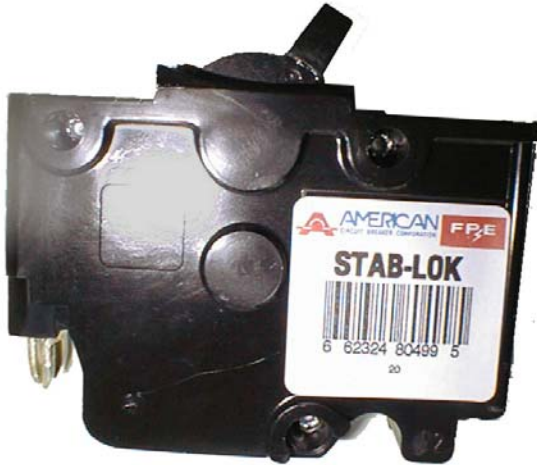
*Figure 10 – Replacement Stablok breaker*

If the breakers themselves are the problem, should homeowners consider replacing the breakers and keeping the panel? At various times over the last 2 decades, different manufacturers have made after-market products designed to fit FPE panels. In some cases, these breakers have been made in Canada, Mexico, or China. Salvaged old FPE breakers are also available from specialty dealers. The breakers sold under the “American” brand (figure 10) are no longer UL listed, though they are listed by ETL, another nationally recognized testing laboratory. In all cases, replacement breakers are very expensive, with a single-pole 15 amp breaker costing as much as \$50. If one wanted to replace all the breakers in a panel, they could spend a great deal more than it would cost to replace the panel with modern listed equipment.
