R. J. Moore Home Inspections

Property Inspection Report

Pleasant Way

GENERAL INFORMATION	3
ROOF SYSTEM	5
ATTIC AND ROOF FRAMING	8
PLUMBING	10
ELECTRICAL	16
HEATING & AIR CONDITIONING	21
GARAGE	25
INTERIOR	27
KITCHEN	33
BATHROOMS	34
LAUNDRY	40
EXTERIOR	41
GROUNDS	44
FOUNDATION	49

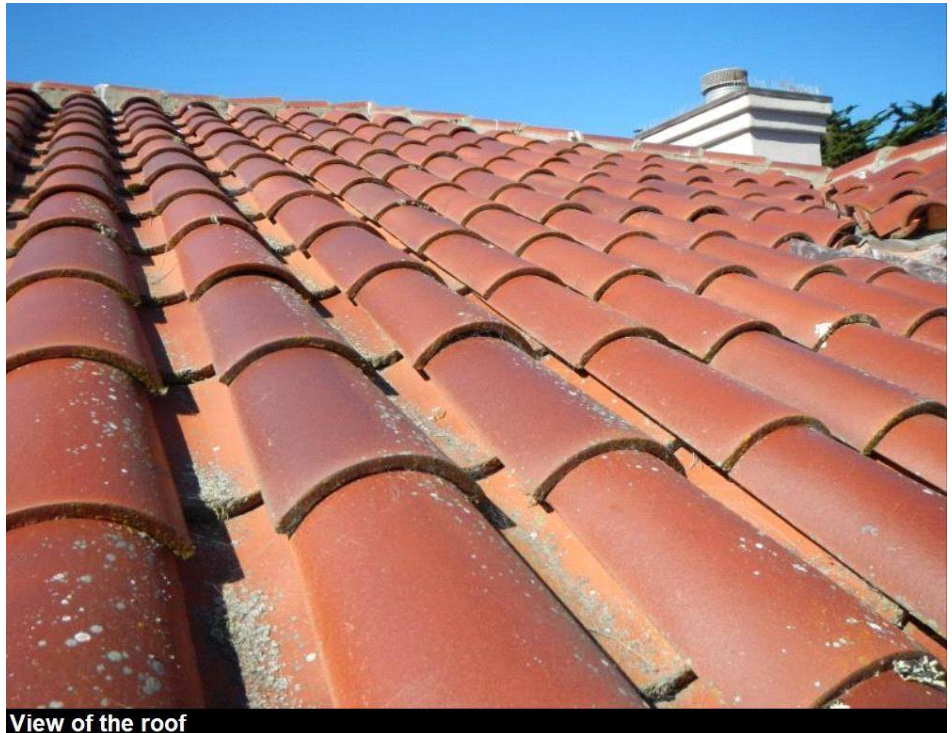
View of the roof

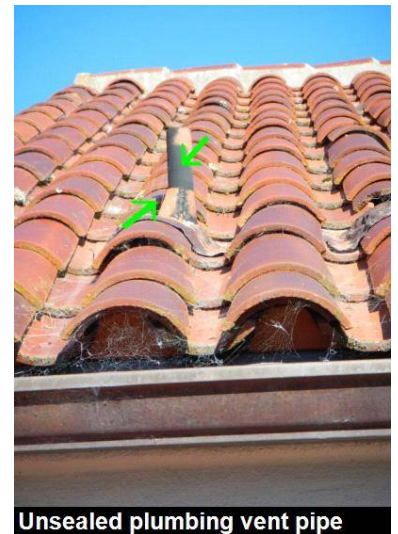
Un sealed transitions between plumbing vent pipes and roof flashing should be fitted with rubber storm collars to prevent water intrusion.

Unsealed plumbing vent pipe

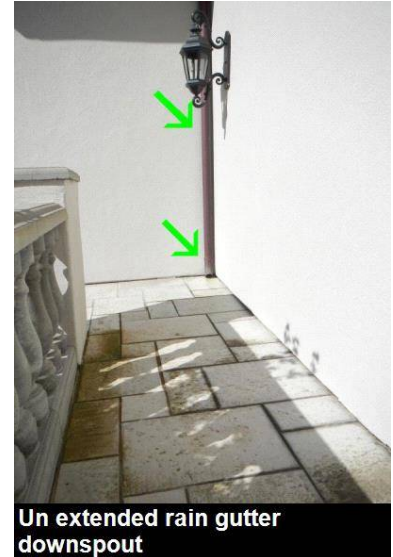
DOWNSPOUT CONDITION:

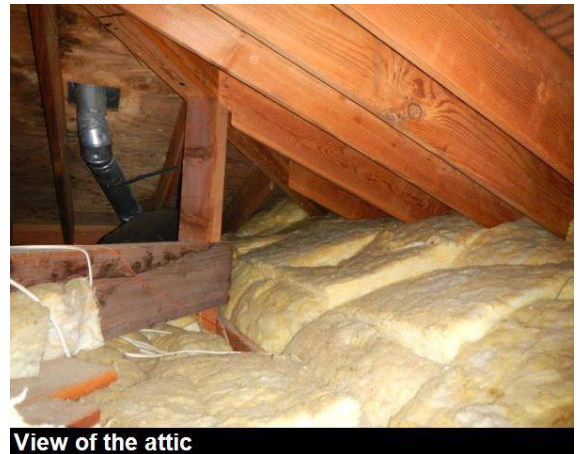
Appeared serviceable where visible. 2X12 wood rafter framing glue laminated wood type structural beams.

View of the attic

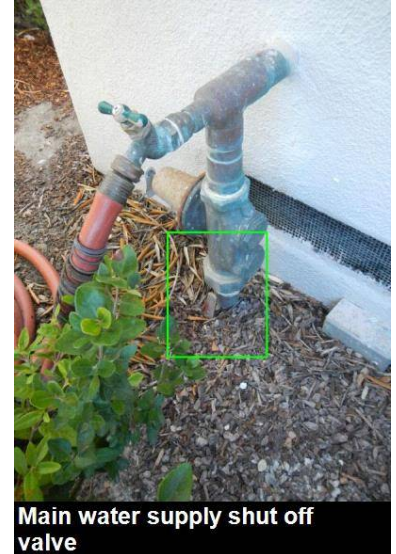
Main water supply shut off valve

The main water supply shut-off valve was in contact with landscape soil, a condition that tends to damage the valve over time. Excessive landscape soil build up should be cleared away to correct.

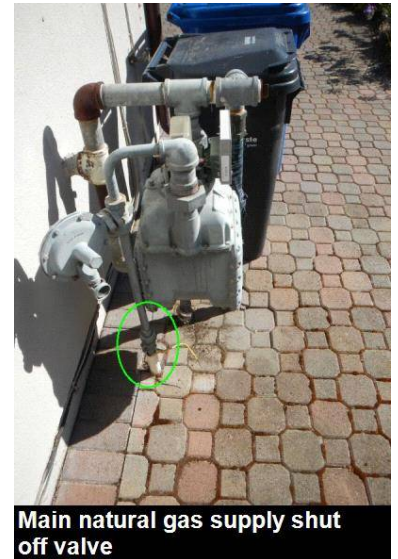
Natural gas. Gas meter and main shut-off valve were located at the rear of the building.

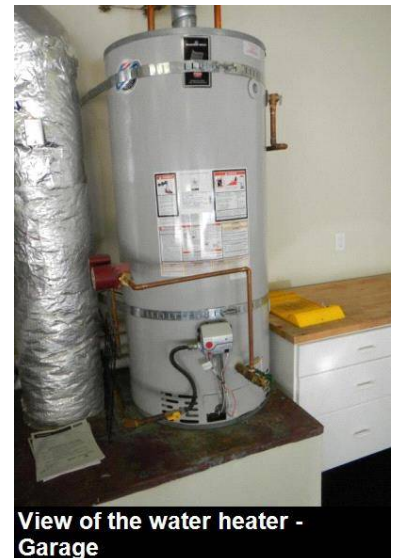
The water heater responded normally when tested. Water heaters of this type typically last 10-15 years. The approximate age of the water heater appeared to be 6 years. Date of manufacture: 2013.

View of the water heater - Garage

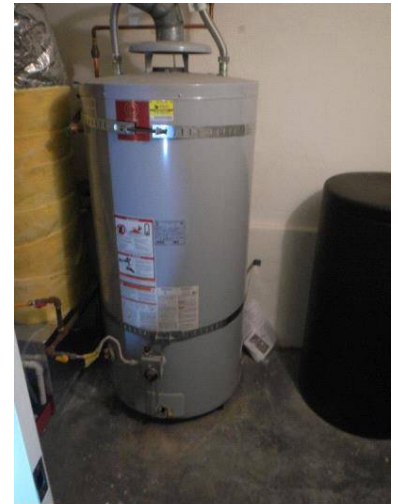
The water heater responded normally when tested. Water heaters of this type typically last 10-15 years. The approximate age of the water heater appeared to be 8 years. Date of manufacture: 2011.

Water heater - Lower level mechanical room

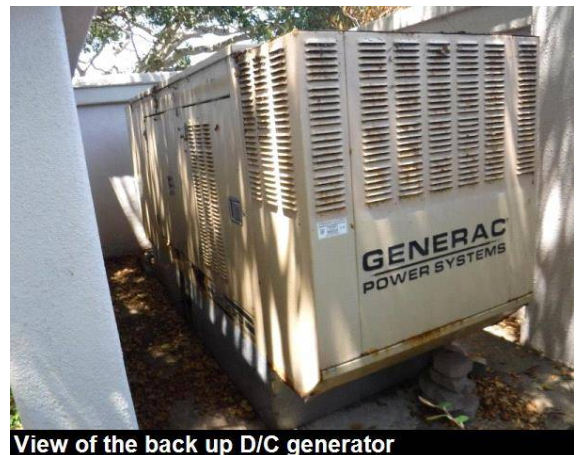
Left side yard alcove: There was natural gas powered D/C generator for backup source during periods of municipal power outage. Alternative power systems are considered specialized systems and equipment, and are not inspected and tested under the general property inspection to verify proper function.

View of the back up D/C generator

An alternative power system specialist should inspect and test the system to determine any improvement is needed.

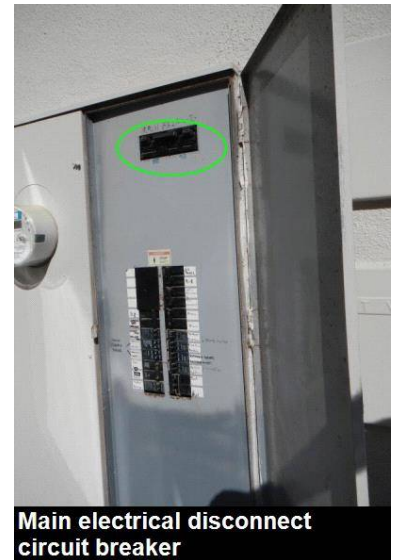
Main electrical disconnect circuit breaker

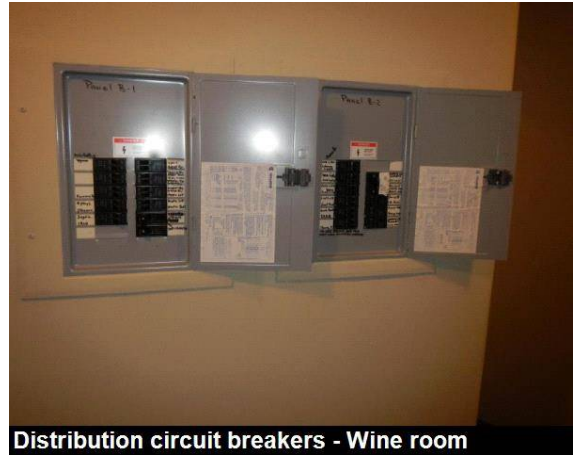
Appeared serviceable. This is the location of some of the distribution circuit breakers.

Distribution circuit breakers - Wine room

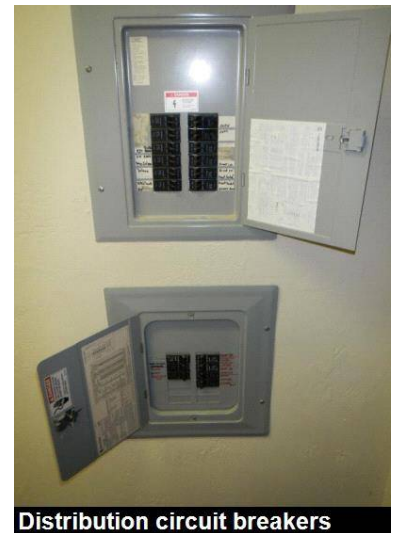
Distribution circuit breakers

Openings at the sub-panel body should be fitted with cover plates for safety.

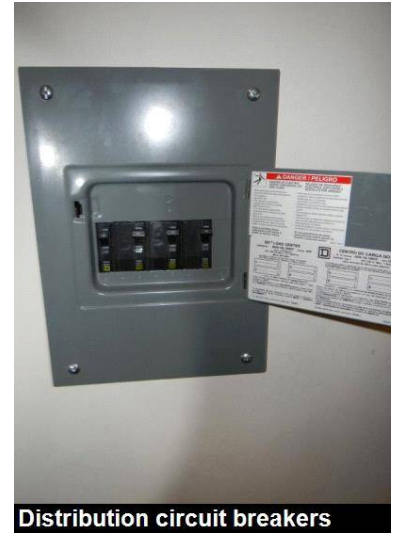
Appeared serviceable. This is the location of some of the distribution circuit breakers.

Distribution circuit breakers

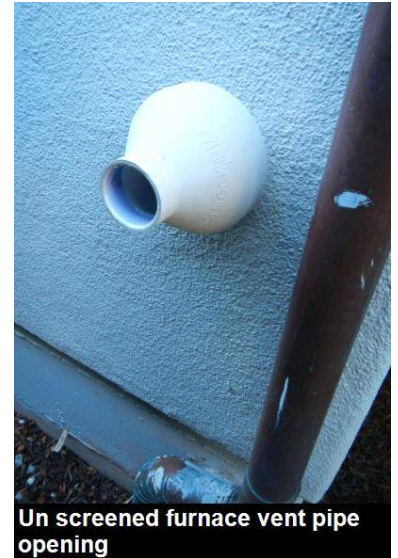
Various locations: The air intake and exhaust pipes should be fitted with proper termination caps with wire screens to prevent foreign objects (small animals) from entering the furnace.

Un screened furnace vent pipe opening

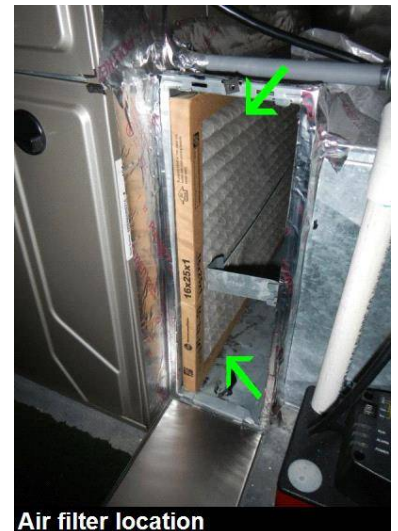
Appeared serviceable. The air filters were located at the air duct work adjacent to the furnaces.

Air filter location

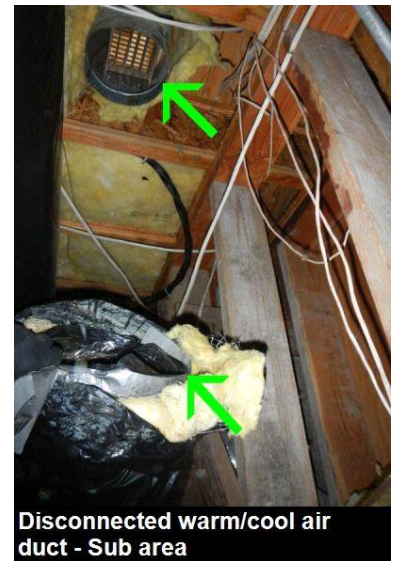
Attic above the master bedroom and various locations in the sub area:
There were disconnected sections of the warm/cool air ducts. Repair is needed.

Disconnected warm/cool air duct - Sub area

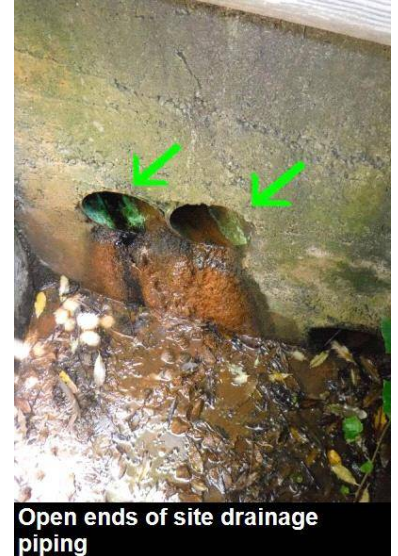
The open ends of the network of underground site drain piping was visible at the lower right front corner of the property, inside of a recessed storm drainage pit.. Functional flow of site water run off should be verified, periodically, as part of the regular maintenance of the building to ensure effective control of site moisture in general.

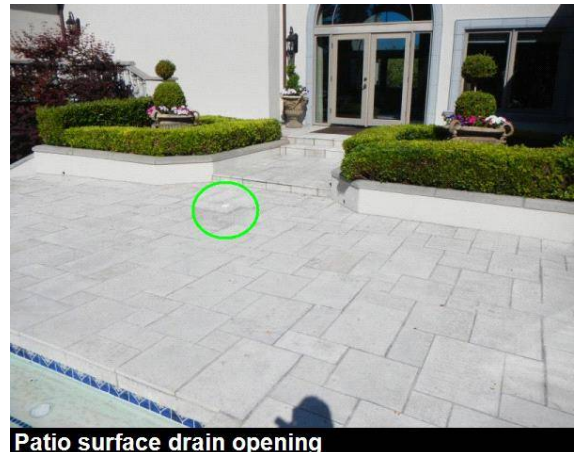
Surface drain openings and associated underground drain piping should be kept clear of debris build up as part of the regular maintenance of the building to prevent potential lower level living space and/or sub area water intrusion as a result of patio water back up (uncontrolled site moisture).

Patio surface drain opening

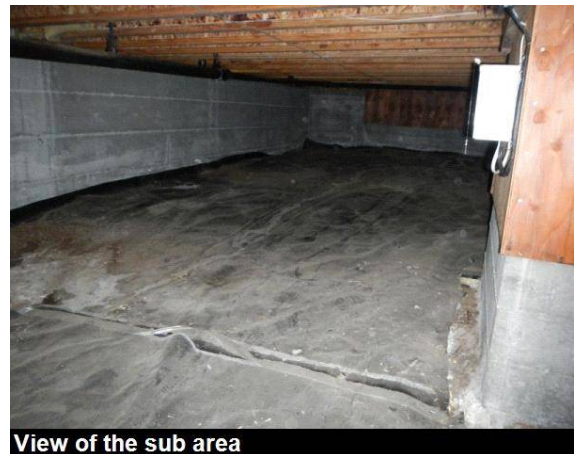
There was a layer of continuous plastic sheeting covering the surface of the sub-area soil apparently a precautionary measure to reduce sub-area humidity. There were minor dry water marks on the exposed surface of the plastic sheeting in various locations, but no evidence of significant sub area water intrusion in the past. Monitor the sub-area for significant increased soil moisture. Improved control of site moisture may be needed if significant moisture increase develops.

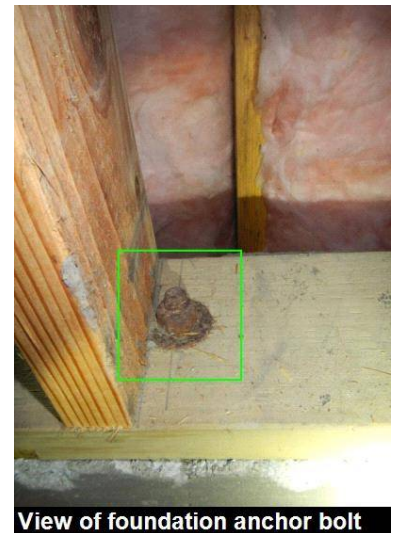
Anchor-bolts (metal bolts that secure the wood framing of the building to the concrete foundation) were installed and appeared serviceable. The importance of anchor-bolts is to reduce the potential for movement of the building during an earthquake.
