Polybutylene for Inspectors

by Nick Gromicko and Kenton Shepard

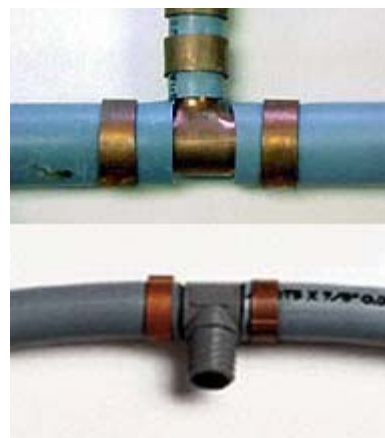
Two studies in particular in papers published by the University of Illinois at Chicago have shown that certain disinfectants can react with the polybutylene and cause it to flake apart at any location within the PB piping system. Small fractures can deepen over time and eventually work their way to the pipe's exterior, allowing water to escape. Some manufacturers, however, claim that the majority of leaks occur at joints and unions, which is where a leak would likely appear if a pipe were improperly installed. Despite this contention, class-action lawsuits filed against PB manufacturers have been successful and resulted in payouts to homeowners reaching \$1 billion.

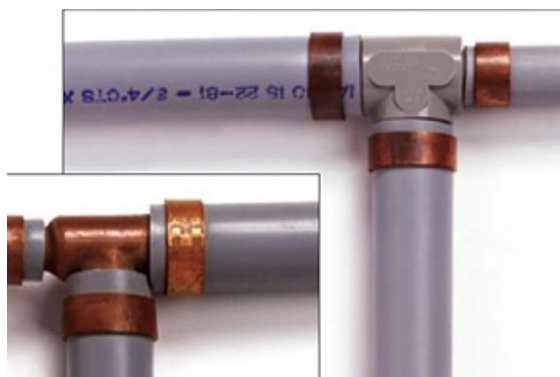
- usually stamped with the code "PB2110";
- flexible and sometimes curved, unlike rigid piping materials such as copper;
- not used for waste, drain or vent piping;

- most commonly grey in color, but they can also be white, silver, black or blue. Blue PB is used primarily outdoors and should only be used to carry cold water. Inspectors should be aware that black or white pipes might not be polybutylene (they might be polyethylene or PVC, respectively). Also, PB color is somewhat region-dependant. For instance, experienced home inspectors in California might never come across grey PB, while it is quite common elsewhere;
- ½” to 1” in diameter.

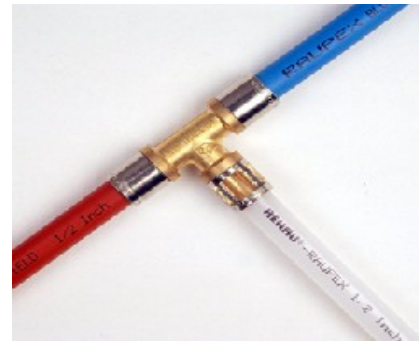
- PEX (pictured at right): Common in radiant-heating systems, this cross-linked polyethylene can be black, blue or red. It is more easily coiled and more flexible than PB. It can withstand higher temperatures than polyethylene.
- PVC: A popular building material commonly used in residential plumbing. CPVC is derived from PVC and is also used in plumbing. Both appear white or off-white and can be flexible or rigid.
- Polyethylene: This material is flexible and black.
- Copper: Copper is a metal that should never be confused with PB.
